**BASIC IMAGERY  
INTERPRETATION  
REPORT**

**PETROVKA NAVAL BASE AND SHIPYARD  
(SHIPYARD ACTIVITIES, JULY - SEPTEMBER 1971)**

**STRATEGIC WEAPONS INDUSTRIAL FACILITIES**

**DECEMBER 1971**

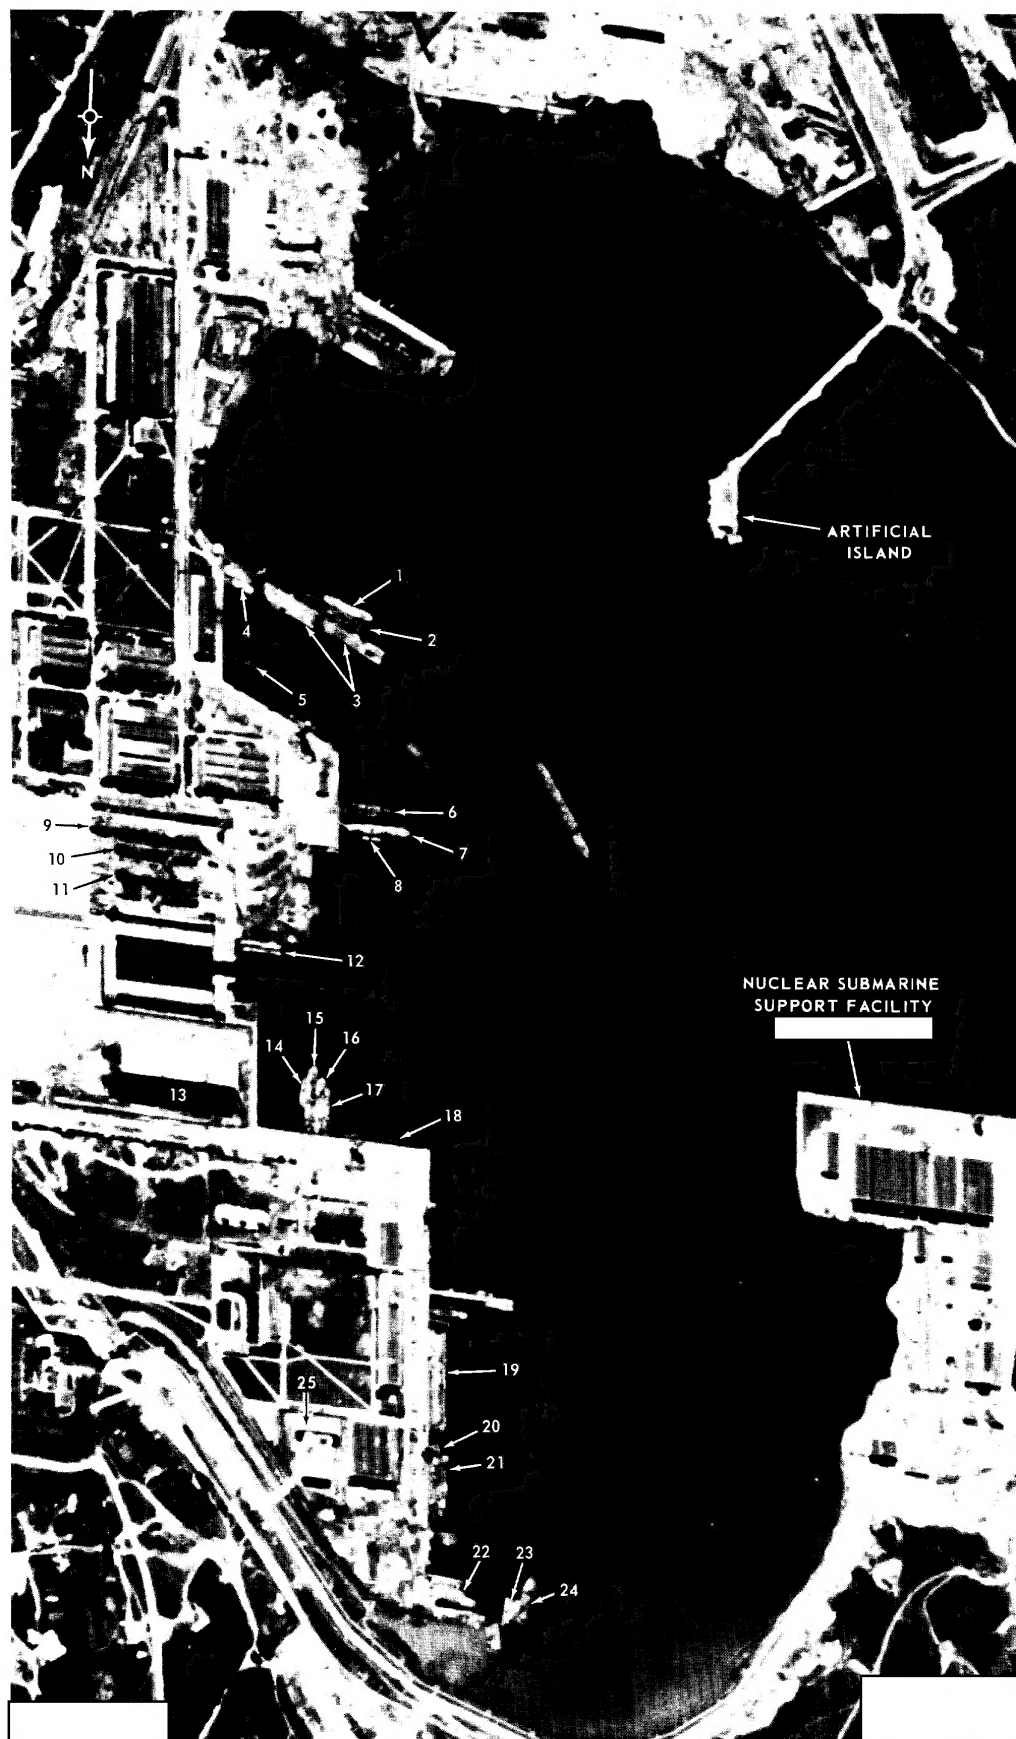
FIGURE 2. PETROVKA NAVAL BASE AND SHIPYARD,

Table 2. Petrovka Naval Base and Shipyard,  
(Keyed to Figure 2)

ITEM	DESCRIPTION
1	Zeya YRSN
2	E-II SSGN
3	2 rectangular support barges
4	Petrovka B YRSN
5	SO-1 SC
6	2 T-58 MSF
7	202-A AR
8	Converted S-1 YFP
9	E-II SSGN on repairway 4
10	N SSN on repairway 3
11	E-I SSGN/SSN on repairway 2
12	2 rectangular support barges
13	Repairway shed in late stages of construction
14	Probable YAG
15	PM-124 YRSN
16	Vala AOSR
17	Possible AOL
18	E-class submarine
19	ARD (T) No 2 transporter dock
20	PM-124 YRSN
21	Petrovka A YRSN
22	Barges
23	Floating crane
24	Probable Zeya YRSN
25	Building in late stages of construction in fitting- out and repair yard
